# THERMAL IMAGING SURVEY:

## AWEL AMAN Tawe CASE STUDY HOUSEHOLDS

COMMUNITY SUMMARY CI-TI

FEBRUARY 2014

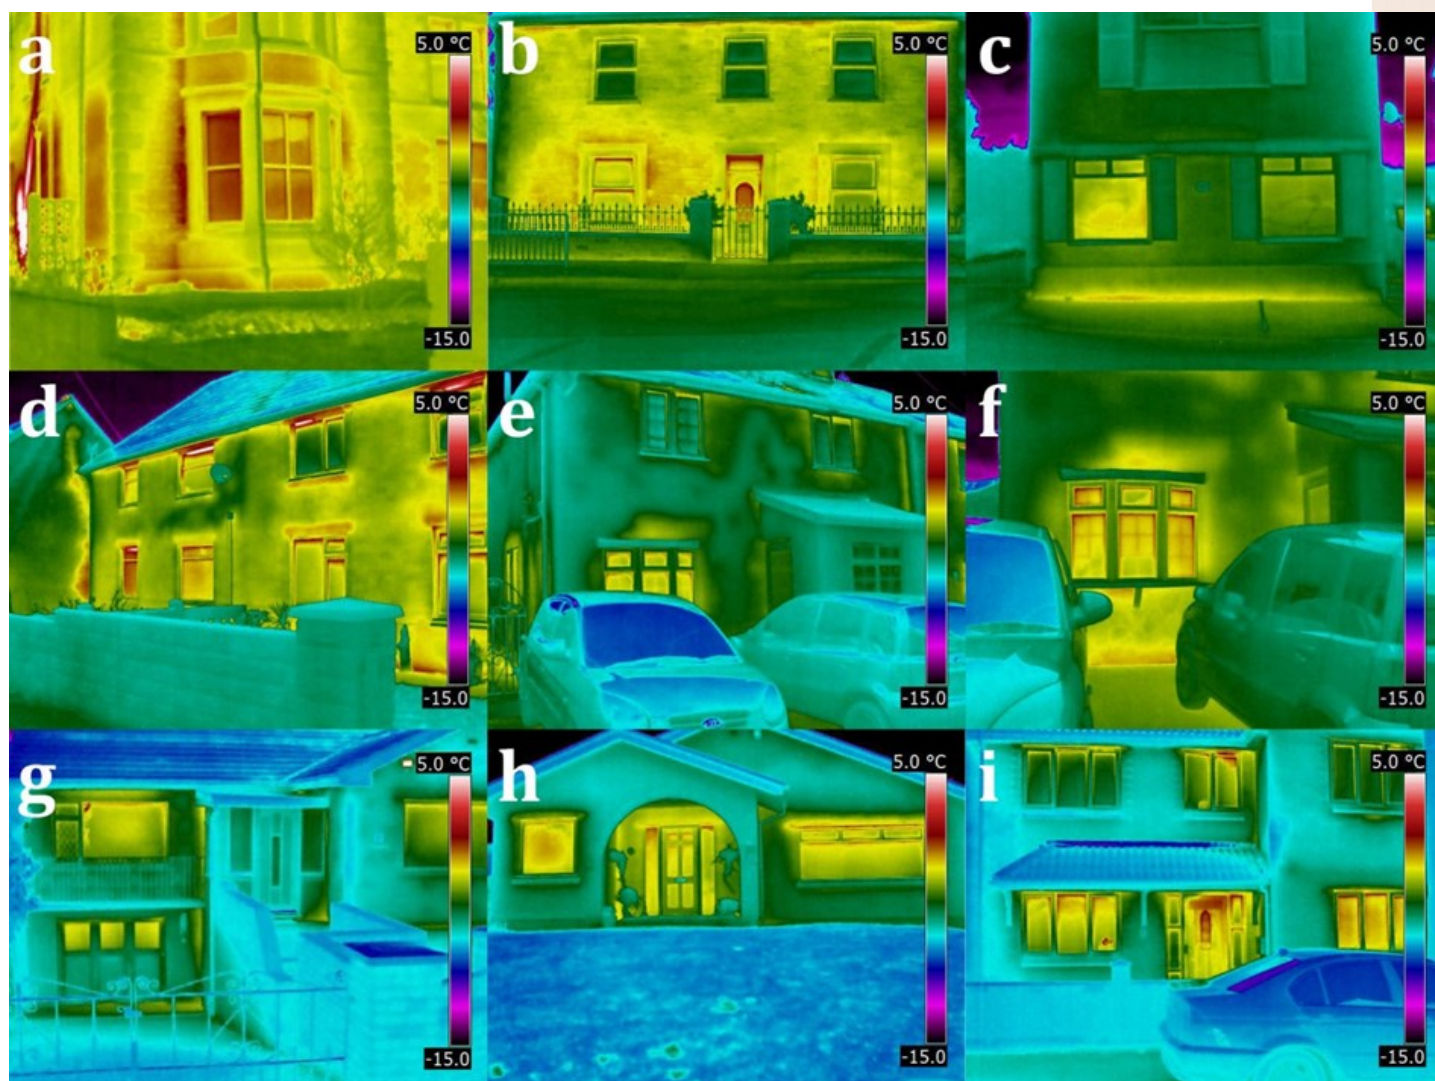
Nine dwellings have cavity wall insulation. Of the dwellings with insulation installed 'as built', the evenness of the walls in the thermograms indicates that the construction was of high quality, and little improvement can be made. This is in contrast to dwellings where top-up cavity wall insulation has been installed. In these dwellings, the external wall appears patchy, possibly indicative of uneven wall insulation in hard-to-reach areas and poor quality workmanship.

Of particular interest is the comparison between dwellings of different ages. Images a-f in Figure 2 show dwellings of both cavity and solid wall construction built prior to 1944 (a-c are solid wall; d-f are cavity wall), whilst Images g-i are dwellings built after 1965. There appears to be a consistent improvement in heat loss reduction and evenness of wall temperatures achieved by the newer dwellings. The images also emphasise the potential issues when retrofitting cavity wall insulation into older dwellings that are likely to have smaller cavities, as shown in the patchiness of

**Figure2.** Images a-c are of dwellings with solid wall construction; Image d is of cavity wall dwelling with no insulation; Images e-f are of cavity wall dwellings with retrofitted insulation; Images g-i are of cavity wall dwellings with insulation installed at time of original construction.

Problem area	Potential reasons	Potential constraints
<b>Roof and eaves</b>		
<b>Eaves</b> (images b & d)	<ul style="list-style-type: none"> <li>- Thermal bridging (not packing loft insulation in tightly to edges)</li> <li>- Gaps in wall/loft insulation (difficulties in installation at construction joints)</li> </ul>	<ul style="list-style-type: none"> <li>- Sheltered nature of feature, resulting in slow dispersal of heat accumulated here during daylight hours</li> <li>- Ventilation gap in loft space</li> </ul>
<b>Walls</b>		
<b>Patchy walls</b> (images a, b, d, e & f)	<ul style="list-style-type: none"> <li>- Poor workmanship of retrofitted cavity wall insulation</li> <li>- Areas of inadequate cavity wall insulation</li> <li>- Blocked-up vents with inadequate insulation and/or thermal bridging</li> <li>- Air gaps within wall construction</li> </ul>	<ul style="list-style-type: none"> <li>- Different materials used within wall construction</li> <li>- Location of external lights (both on dwelling itself and streetlights reflecting light (and heat) onto external wall</li> <li>- Internal rooms heated to higher temperatures than others</li> </ul>

<b>Joints/connection details</b> (images a, e & g)	<ul style="list-style-type: none"> <li>- Thermal bridging due to lack of insulation at junctions between walls etc.</li> <li>- Poor workmanship of retrofit improvements</li> </ul>	<ul style="list-style-type: none"> <li>- Sheltered nature of feature, resulting in slow dispersal of heat accumulated here during daylight hours</li> </ul>
<b>Chimney breasts</b> (image a & d)	<ul style="list-style-type: none"> <li>- High temperatures due to use of fire; lack of insulative lining</li> <li>- Direct access for air flow in and out of building</li> </ul>	
<b>Windows and doors</b>		
<b>Heat loss around lintels</b> (images d, e, f & h)	<ul style="list-style-type: none"> <li>- Thermal bridging</li> <li>- Gaps in draught-proofing of windows/doors</li> </ul>	<ul style="list-style-type: none"> <li>- Lintels made of different materials (eg. Concrete, timber)</li> <li>- Sheltered nature of feature, resulting in slow dispersal of heat accumulated here during daylight hours</li> </ul>

<b>Bay and extruded windows</b> (images a & f)	<ul style="list-style-type: none"> <li>- Poor construction particularly at joints allowing heat loss</li> <li>- Lack of insulation (difficult to install)</li> </ul>	<ul style="list-style-type: none"> <li>- Different materials used within wall construction</li> <li>- Sheltered nature of feature, resulting in slow dispersal of heat accumulated here during daylight hours</li> </ul>
<b>Heat loss under window cills</b> (images d, e, f & i)	<ul style="list-style-type: none"> <li>- Lack of insulation (difficult to install)</li> <li>- Gaps in draught-proofing of windows</li> <li>- Poor workmanship in relation to sealing and draught-proofing window frames</li> <li>- Indicative of localised 'hot' spots (generally due to radiator located on external wall beneath window)</li> </ul>	<ul style="list-style-type: none"> <li>- Sheltered nature of feature, resulting in slow dispersal of heat accumulated here during daylight hours</li> </ul>

<b>Other</b>		
<b>Ground level heat loss</b> (image a, c & f)	<ul style="list-style-type: none"> <li>- Ventilation due to suspended flooring</li> <li>- Lack of insulation on ground floor of dwelling</li> <li>- Lack of damp-proofing course (DPC)</li> </ul>	<ul style="list-style-type: none"> <li>- Dampness at ground level</li> <li>- Vegetation at ground level</li> </ul>

the walls in Images 2e and 2f in comparison to Image 2h.

A key learning of the thermographic survey of dwellings in Cwmlllynfell and Ystradowen appears to be the difficulties in retrofitting cavity wall insulation in certain dwelling types in the area; mainly 1919-44 dwellings with narrow cavities. Out of the four dwellings of this type in the study, all have much patchier external walls than the other dwellings in the area. Whilst fluctuations in surface temperature is highly reliant on contextual variables such as weather conditions, nearby vegetation and adjacent lighting sources, it does seem to indicate a specific issue with dwellings of this type and the high level of workmanship required in order to significantly reduce heat loss through retrofit measures. In a large number of the dwellings studied, 'hot spots' beneath windows, even in a relatively new dwelling (post-1990),

indicate that sealing of window systems, and ensuring insulation is fully packed at these junctions are critical issues. In addition, a number of properties appear to suffer from high temperatures (ie heat loss) at ground level, which is indicative of the importance of floor insulation and/or high quality construction of the foundation details and wall/ground junction.

Given the complexities in interpreting thermal images, it is often difficult to ascertain the exact causes of anomalies in the images. Further investigation of 'hot' spots below windows in particular would be recommended, as it could be indicative of poor installation of cavity wall insulation or the glazing systems themselves.
