Assessment of the performance of cavity and solid wall dwellings

A shared learning resource from the EVALOC project

January 2014

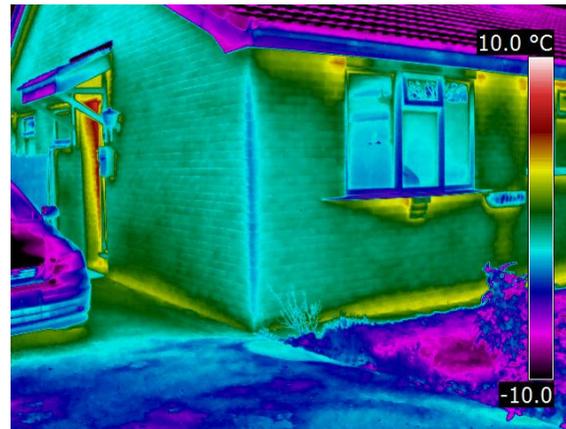
Figure 2. Thermal image showing outside corner which appears cooler than rest of building (likely effect of exposure to wind) and inside corners (below cills and eaves) that appear warmer (possible effect of sheltering).

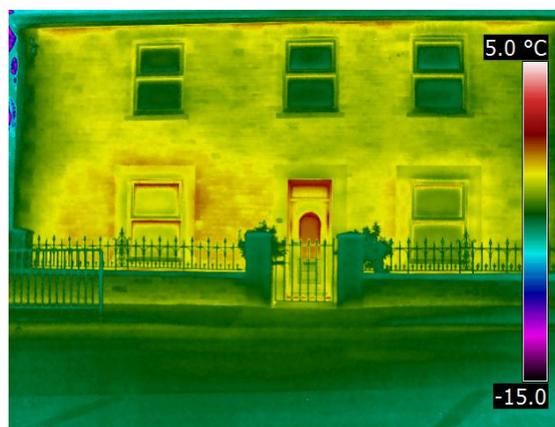
Figure 5. Higher temperatures at ground floor level to left; this room is heated to higher temperatures than rest of building, creating an anomaly in the consistency of the façade,

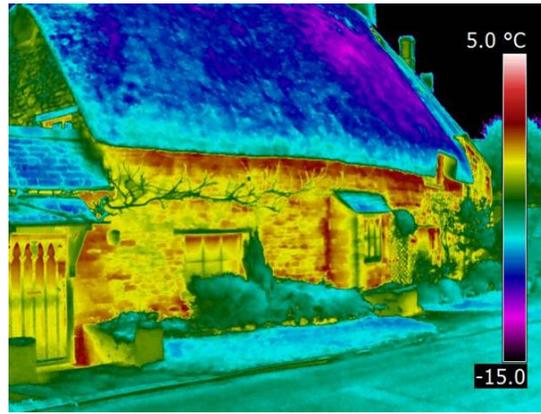
Figure 6. Solid stone wall dwelling, patchy wall finish indicative of different stone types being used (with different emissivities).

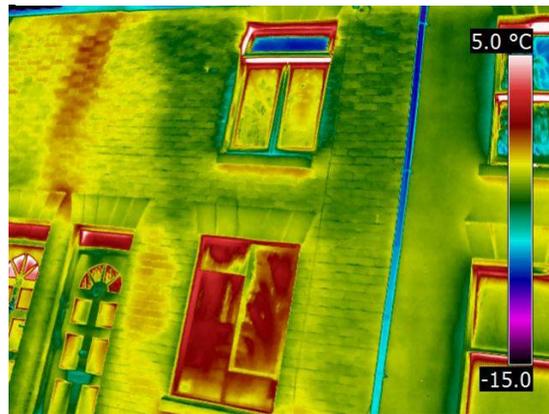
Figure 7 shows a rare anomaly in the case study solid wall dwellings; and is worthy of a further visual inspection to rule out hairline cracks and/or issues with the mortar, creating air gaps within the external wall.

Figure 7. Solid brick wall dwelling (painted) with vertical strip of higher temperatures (possible heat loss through cracks in mortar).

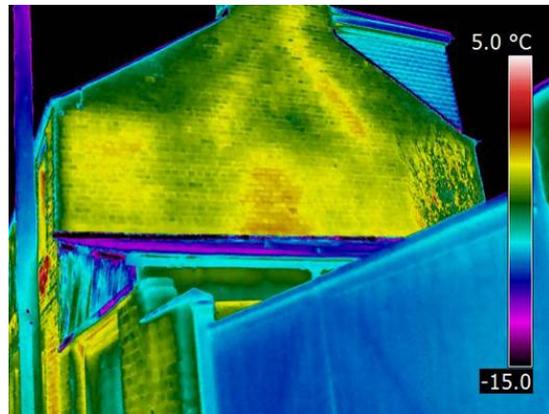
Figure 8. Solid brick wall dwelling with chimney stacks visible, and line of loft insulation present.

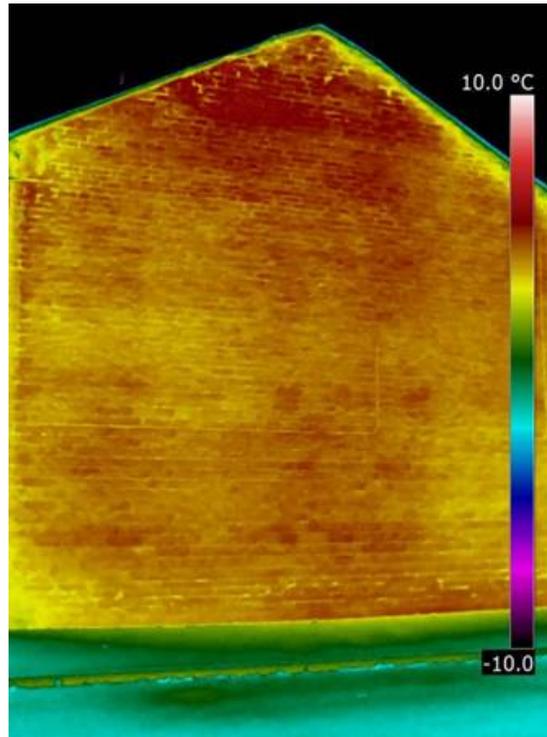
Figure 9. Solid stone wall dwelling with room in roof (insulation at eaves level). Higher temperatures apparent in room in roof.

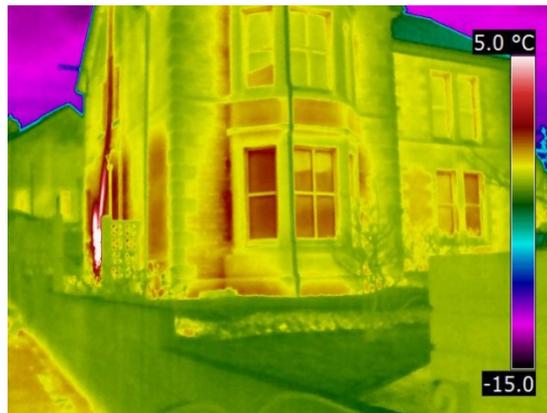
The survey also suggests that 17 out of the 34 dwellings have issues with potential heat loss at wall junctions, particularly around bay windows with all of the 14 dwellings with bay windows showing significantly higher temperatures at the junctions between the bays and the main building. Generally, the bay windows are of a different construction and material but even in buildings where they are of the same material, higher temperatures are present (Figure 10). Whilst the higher temperatures could be due to the sheltered nature of these areas, it is also potentially indicative of cracks along the junctions, poor workmanship in these areas and/or degradation of the materials and mortar joints.

Figure 11. Solid stone wall dwelling, higher temperatures at bay window junctions.

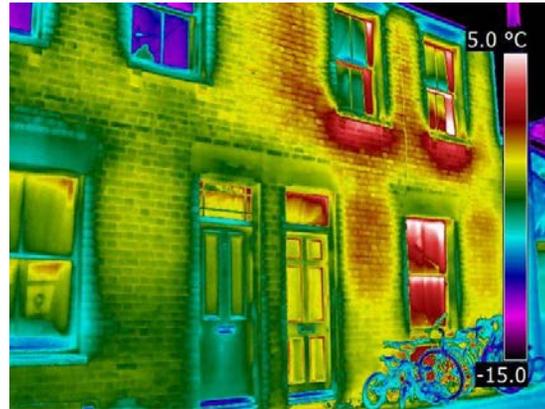
Figure 12. Solid brick wall dwelling, localised elevated temperatures below windows (upper level).

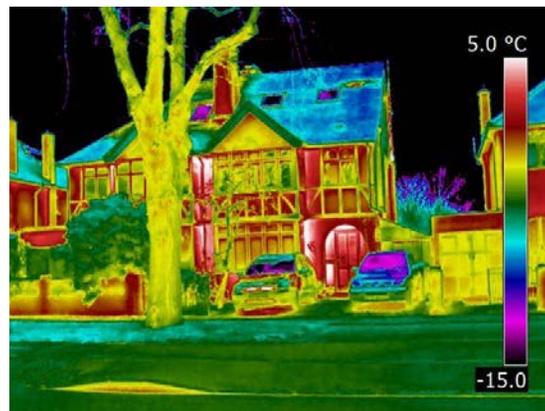
Inset entrance porches also appear to be a source of heat loss; with all 12 of the dwellings with them showing higher temperatures around the frames. The images (Figure 13) corroborate the findings from the semi-structured interviews that most of the dwellings with this feature, although having improved their window glazing have not upgraded their doors and subsequently the fixed single glazing and frames adjacent. In addition, the wall adjacent to the heated space may also have been built as a single leaf (particularly in solid brick buildings) to increase internal floor area thus reducing its thermal properties. Despite this, due to the sheltered nature of these areas, it is likely that the apparent increase in temperatures may be due, in part, to thermal storage and/or shelter from night sky radiation.

Figure 13. Render and exposed solid brick wall dwelling, high temperatures apparent in inset entrance porch (single glazed, and no draughtproofing).

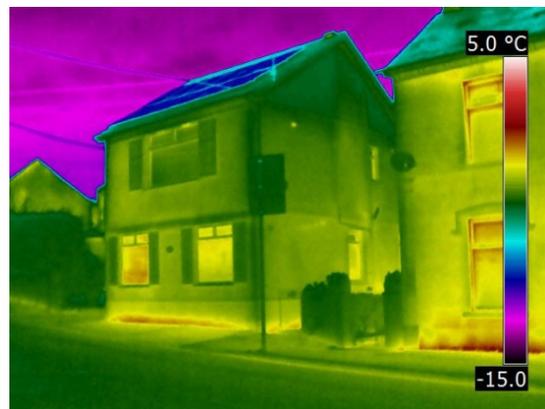
Five dwellings showed signs of higher temperatures at ground level (Figure 14); although due to obstructions it is possible that more buildings may also suffer from this. Whilst this can be indicative of damp, it can also point to heat loss due to lack of sealing of suspended floors.

Figure 14. Rendered solid wall dwelling, higher temperatures visible at ground level (possible heat loss through floor).

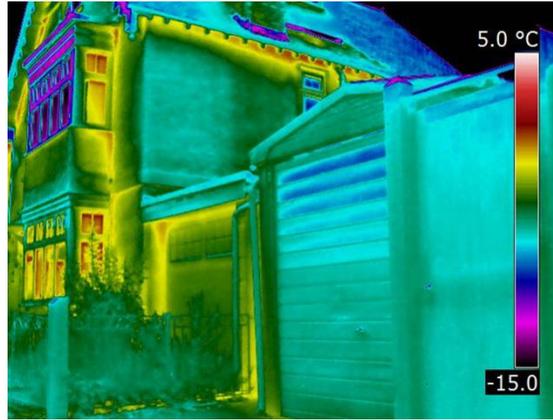
Whilst there were only three dwellings with retrofitted solid wall insulation (that were included in the survey), the images provide interesting results; Figure 15 shows a render finish wall (solid brick construction) with internal wall insulation. As can be seen there appears to be issues with the continuity of the insulation, particularly around the junctions with the bay windows and up within the eaves. Figure 16 also shows a rendered brick façade with internal wall insulation around the bay window. In comparison to the adjacent building, the insulation does appear to have improved the performance of the bay window but the overall surface is still uneven suggesting air gaps or voids within the insulation. In contrast Figure 17 shows external wall insulation with render finish (solid stone construction) that appears to have been installed well; with continuity in surface finish across the façade. Although unable to survey the other dwelling with external wall insulation adequately, it too appears to provide an even finish; much more so than that achieved by internal wall insulation, even though it is on the same building.

Figure 15. Solid wall dwelling, possible heat loss to eaves and corner junctions. Line of internal wall insulation visible at upper level.

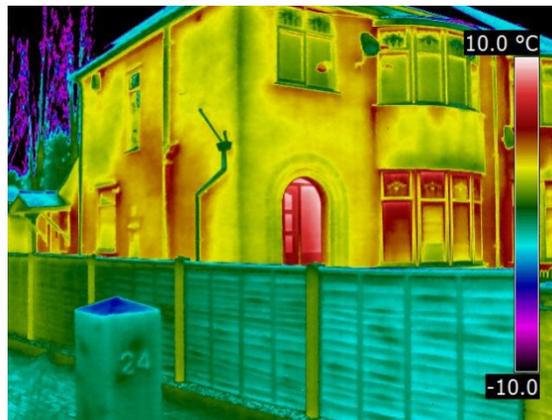
Figure 16. Rendered solid wall dwelling, with internal insulation installed in bay window. Bay window appears patchy suggesting loss of performance in the internal wall insulation.

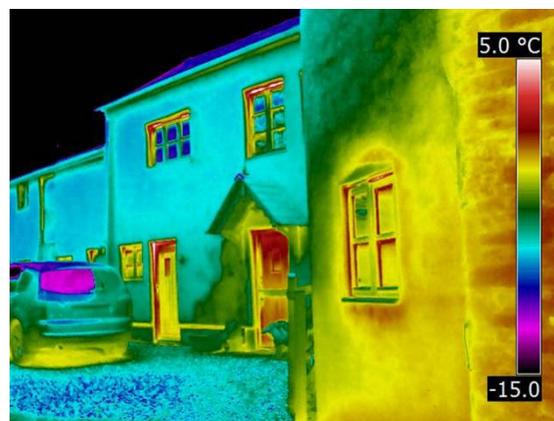
Figure 17. Solid stone wall dwelling with rendered external insulation, continuous finish visible but areas of higher temperatures around windows and doors.

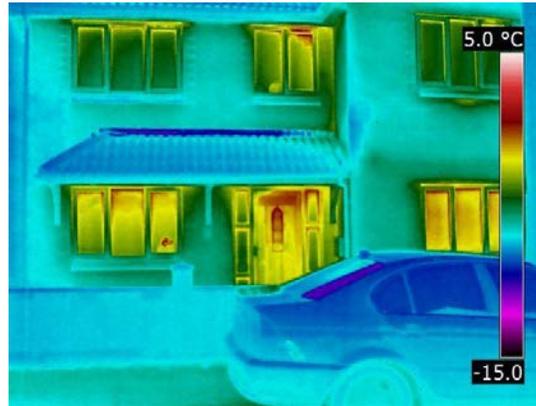
Figure 18. Brick cavity wall dwelling (built post-1990), showing relatively continuous temperatures across façade.

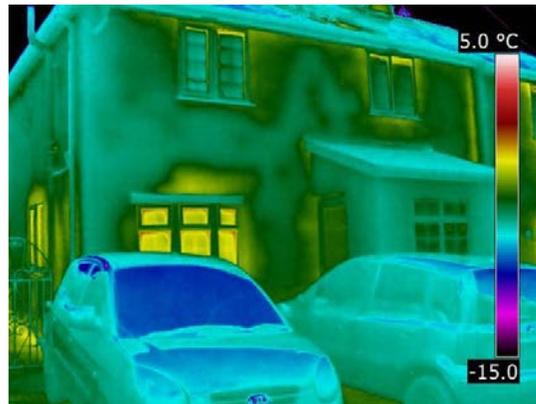
Figure 19. Rendered cavity wall dwelling with retrofitted insulation, showing lack of consistency across facade.

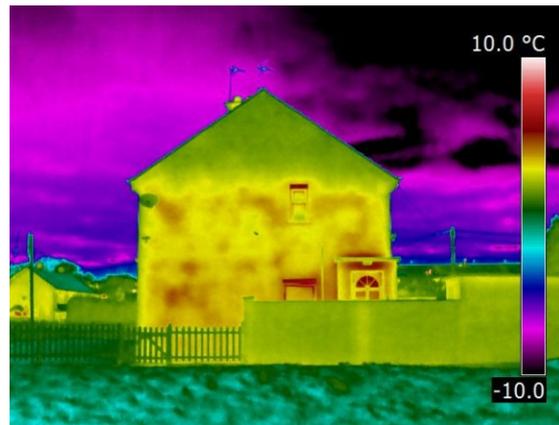
Figure 20. Brick cavity wall dwelling with both loft and cavity wall insulation (CWI), visibly patchy temperatures across façade suggesting voids in insulation; clear line along loft insulation level showing effectiveness of loft insulation.

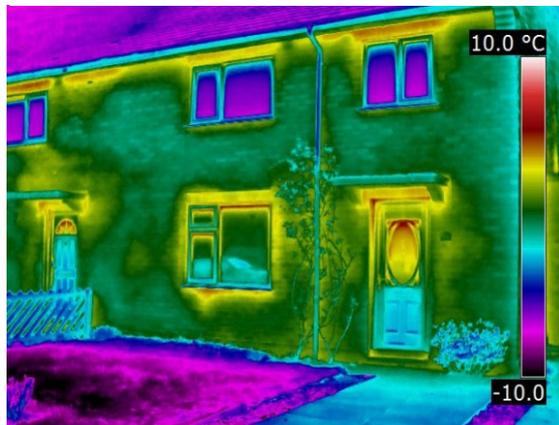
Figure 22. Brick cavity wall dwelling with insulation, apparent lack of draughtproofing/insulation around windows and doors.

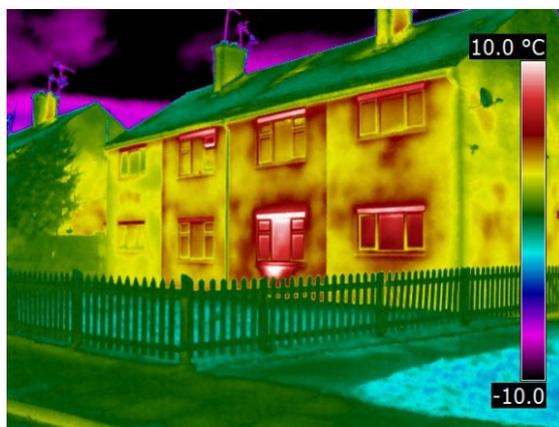
Figure 21. Brick cavity wall dwelling with insulation, patchy finish across façade and apparent heat loss beneath windows, particularly middle ground floor window.

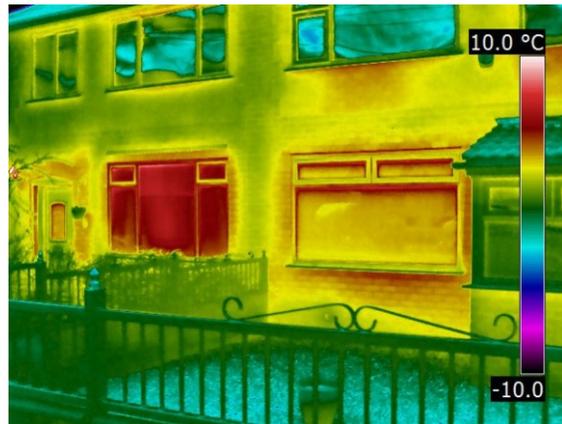
possibly not expected to be as obvious in cavity wall dwellings as it is in solid wall dwellings, due to the pattern and location of the higher temperatures in Figure 23 in the dwelling to the right in comparison to the dwelling on the left, it appears that localised heat loss from radiators is as relevant to cavity wall properties. Interestingly, it is known that the dwelling to the left was given radiator reflector panels by the local community group. It appears that this is a successful action in terms of reducing heat loss.

Figure 23. Brick cavity wall dwelling with insulation, apparent localised heat loss beneath windows (location of radiator). Dwelling to left has radiator reflector panels.

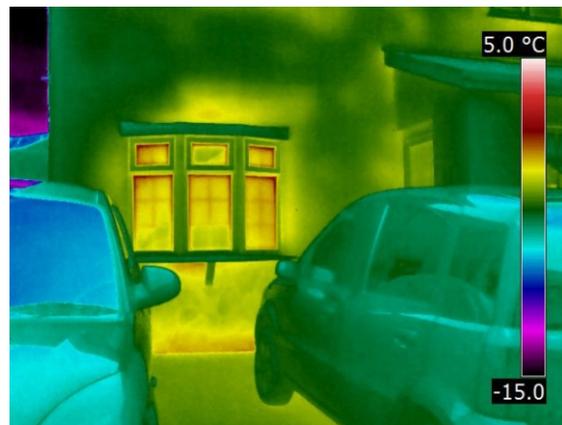
Figure 24. Rendered cavity wall dwelling with insulation, projecting window design creating higher temperatures around junction with main wall.

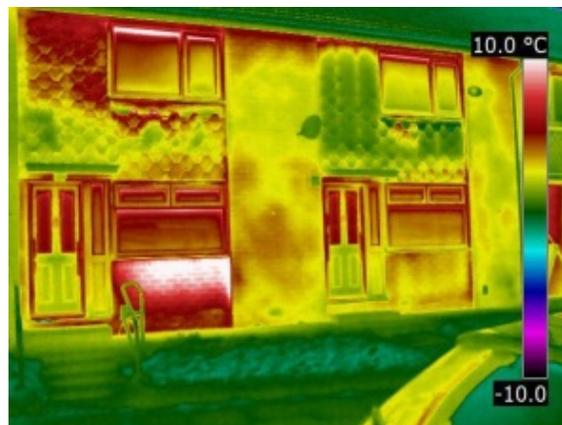
Figure 25. Brick and tile cladding finish cavity wall dwelling (assumed uninsulated), showing fluctuations across façade, particularly below window cill and at high level beneath cladding.

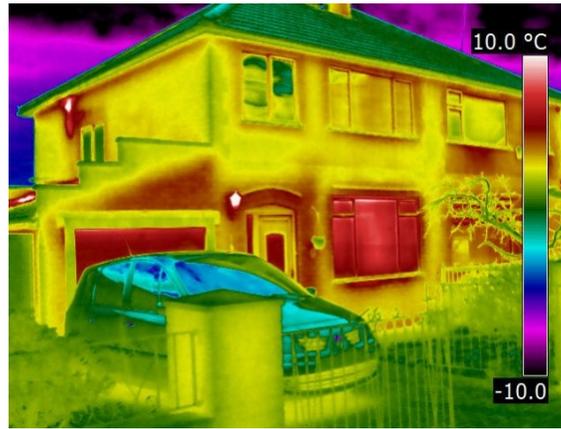
Figure 26. Brick cavity wall dwelling with insulation showing higher temperatures in unheated but adjoined garage space.

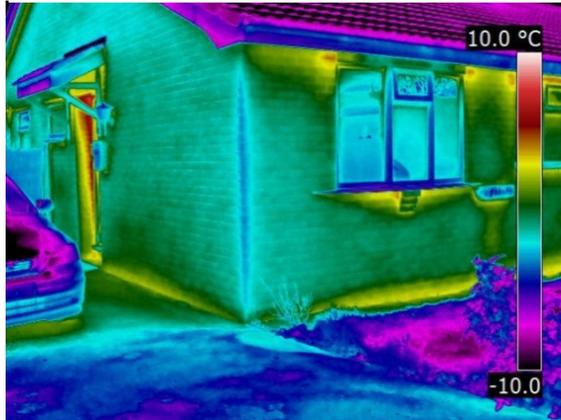
Whilst further investigation was not undertaken as part of this study, evidence from other research (Miles-Shenton et al., 2011) suggests that this is potentially indicative of cavity wall insulation not extending below the DPC line. As such, particularly in suspended floor buildings, this could create air passages from the internal heated spaces to outside at ground level.

Figure 27. Brick cavity wall dwelling (insulation as built) with apparent heat loss at ground level.
