This Thermal Imaging survey was prepared by the Low Carbon Building Group, Oxford Brookes University as part of the EVALOC project. Please be advised that whilst every effort has been made to ensure their accuracy, these thermograms should be interpreted within the context of the constraints of the survey, including access, weather conditions and physical context (as outlined in section 1). Oxford Brookes University accepts no responsibility for any works arising as a result of these findings and strongly recommends further investigation of the thermal performance of these properties before any such works are undertaken.

Introduction

This report summarises the findings of a thermographic survey conducted on 13th March 2013 of these 17 homes.

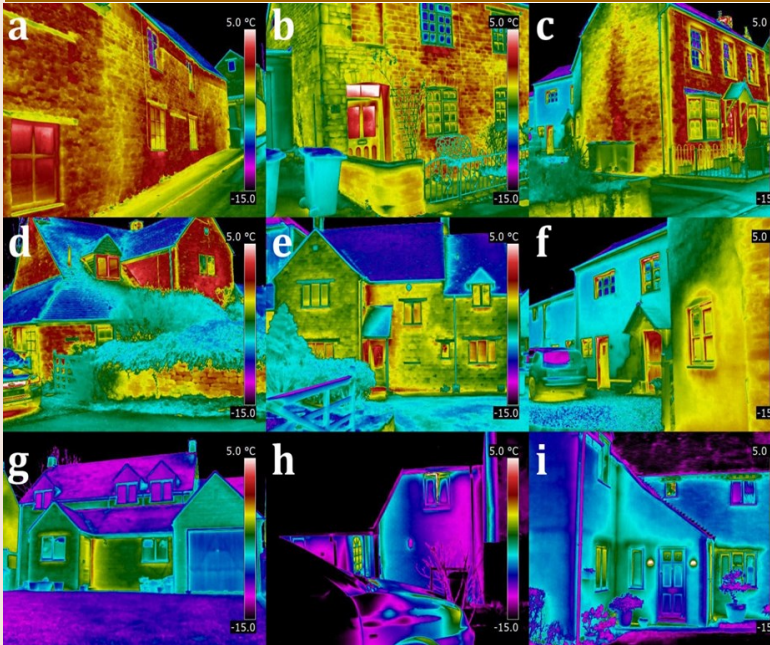
Figure 1. Images a-c are of dwellings with solid wall construction; Images d, e are of cavity wall dwellings with insulation as existing; Image f is of a solid wall dwelling with retrofitted external wall insulation; Image g is of a cavity wall dwelling with recent fabric improvements; Images h and i are of cavity wall dwellings with insulation as existing..

Within the dwellings built post-1965, there appeared to be quite a disparity in surface temperatures. Whilst external constraints should be taken into consideration, it does suggest differences in quality of construction between dwellings. Figures 1d and 1g are both 1965-80 detached dwellings, with stone finish. However, the dwelling shown in 1g has undergone substantial renovation, and improved fabric interventions. Similarly, Figures 1e, 1h and 1i are all

Problem area	Potential reasons	Potential constraints
Walls		
Patchy walls (images a, b & e)	<ul style="list-style-type: none"> • Poor workmanship of cavity wall insulation • Areas of inadequate cavity wall insulation • Air gaps within wall construction 	<ul style="list-style-type: none"> • Different materials used within wall construction • Location of external lights (both on dwelling itself and streetlights reflecting light (and heat) onto external wall • Internal rooms heated to higher temperatures than others
Joints/ connection details (images d, e & g)	<ul style="list-style-type: none"> • Thermal bridging due to lack of insulation at junctions between walls/dormer windows etc. 	
Chimney breasts (image c)	<ul style="list-style-type: none"> • High temperatures due to use of fire; lack of insulative lining • Direct access for air flow in and out of building 	
Windows and doors		
Heat loss around windows/doors (images b, e & f)	<ul style="list-style-type: none"> • Thermal bridging • Gaps in draught-proofing of windows/doors • Poor construction particularly at joints allowing heat loss • Lack of insulation (difficult to install) 	<ul style="list-style-type: none"> • Different materials used within wall construction • Sheltered nature of feature, resulting in slow dispersal of heat accumulated here during daylight hours

Heat loss under window cills (images a, c, e & g)	<ul style="list-style-type: none"> • Lack of insulation (difficult to install) • Gaps in draught-proofing of windows • Poor workmanship in relation to sealing and draught-proofing window frames 	<ul style="list-style-type: none"> • Cills made of different materials (eg. Concrete, timber) • Sheltered nature of feature, resulting in slow dispersal of heat accumulated here during daylight hours
Other		
Ground level heat loss (images a, c & f)	<ul style="list-style-type: none"> • Ventilation due to suspended flooring • Lack of insulation on ground floor of dwelling • Lack of damp-proofing course (DPC) 	<ul style="list-style-type: none"> • Dampness at ground level • Vegetation at ground level

detached properties built between 1981-90, yet demonstrate potential different levels of heat loss. It must be noted however, that the dwellings shown in Figures 1h and 1i are brick finish, whilst 1e is stone. Overall however, the appearance of the cavity wall dwellings appears generally 'smooth' and as such suggests a good quality of construction.

Within a number of dwellings, there appear to be 'hot spots' below windows, which suggests a need for draughtproofing and/or poor quality window installations (Figures 1a and 1e). Interestingly, in Figure 1a, there are no radiators below the windows, indicating that this is not simply an issue of increased localised heating.

A number of the solid wall dwellings show 'patchy' surfaces to the external wall but these generally correspond with the stone, and it is believed that due to the majority of these dwellings being built with random stone, this may simply be indicative of the different types of stone used in the construction. Figure 1f demonstrates the impact of external solid wall insulation on reducing heat loss, whilst also highlighting possible areas of heat loss around window and door frames. Figures 1b and 1c further indicate two main areas of heat loss (other than below windows) in solid wall dwellings in this survey; poorly sealed external doors and fanlights, and chimneys.

Given the complexities in interpreting thermal images, it is often difficult to ascertain the exact causes of anomalies in the images. Further investigation of 'hot' spots below windows in particular would be recommended, as it could be indicative of poor installation of the glazing systems.
