THERMAL IMAGING SURVEY: EASTERSIDE CASE STUDY HOUSEHOLDS

COMMUNITY SUMMARY C3-T1

FEBRUARY 2014

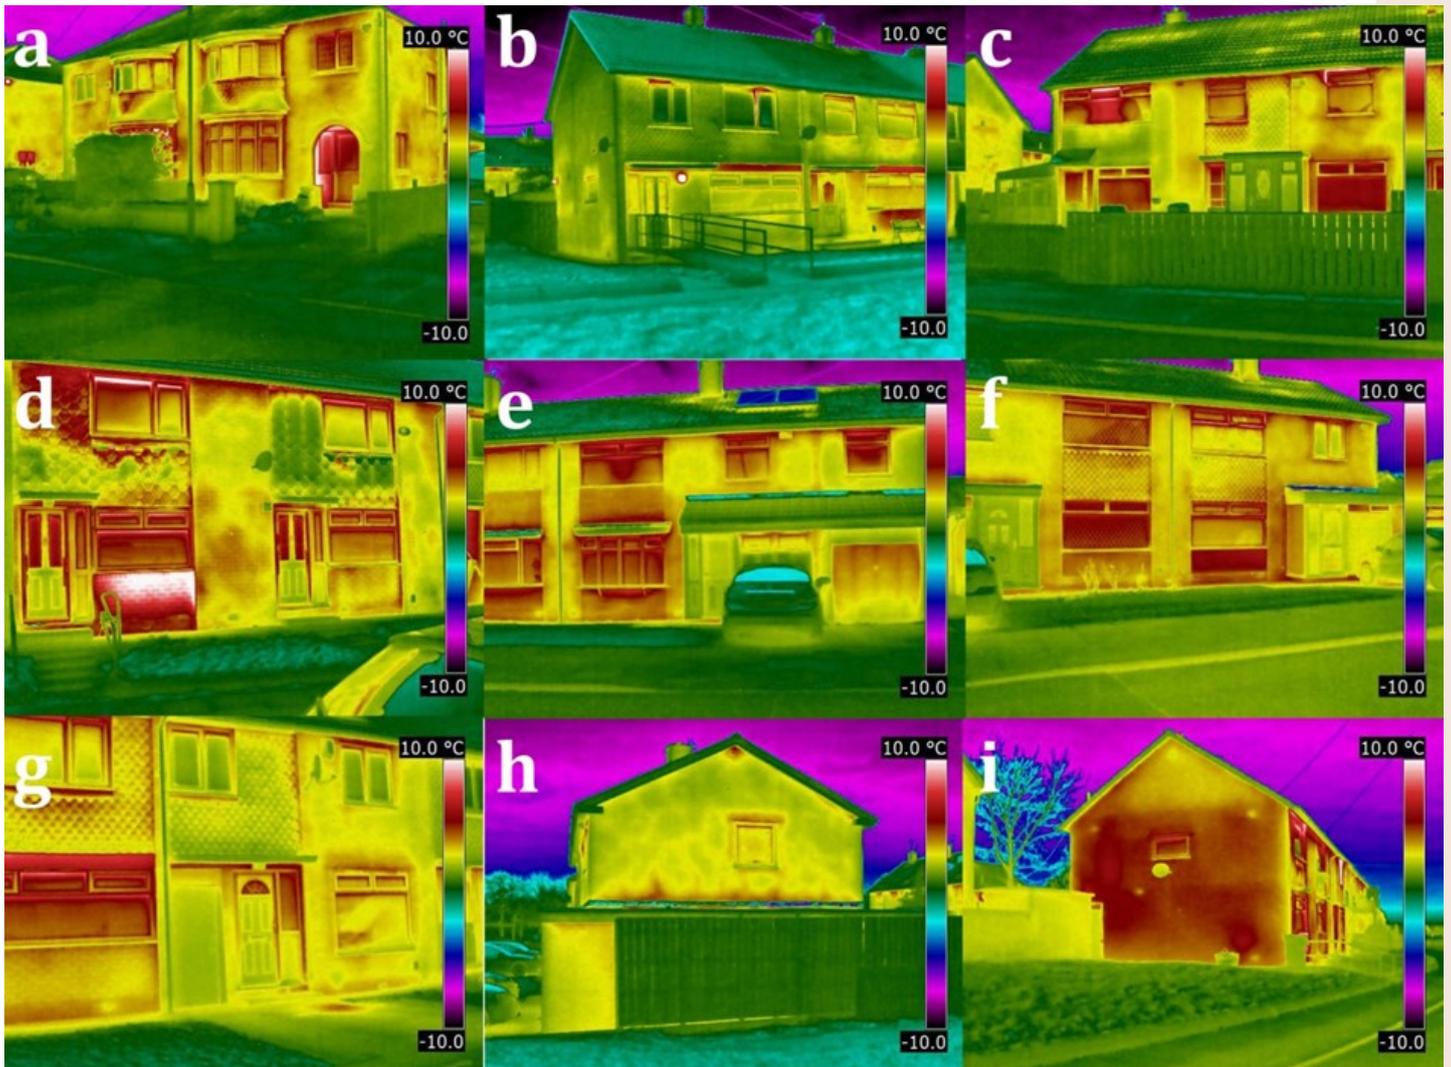
Figure 4. Set of images showing common issues highlighted during the thermal imaging survey.

The majority of the dwellings in this survey were built post-war (1945-64) with cavity wall construction. Most have had both cavity wall and loft insulation top-ups in the last twenty years. When comparing the images of the dwellings, distinct ‘patchiness’ to the external walls can be seen on most of the buildings. This could indicate an overall issue with retrofitting cavity wall insulation in this area.

A difficulty presenting itself in the interpretation and comparison of the images is the fact that the indoor temperature is unknown. Figure 2c particularly highlights this as it is highly likely that the dwelling to the left of the image is not being heated to the same levels as the adjoining property (due to contextual data known to researchers). As such, although this dwelling appears to be losing less heat, it may simply be due to the variation in the difference in internal and external temperatures between the two dwellings.

From the survey, it is also very difficult to assess the performance of loft insulation in the dwellings; in some there is a clear definition of the line of loft insulation (Figure 2i) but in a number of other dwellings the line is not visible. This suggests that a similar amount of heat is being lost from the

loft as the walls. As the loft is unlikely to be a heated space, this is an area that is worth further investigation.

Problem area	Potential reasons	Potential constraints
Roof and eaves		
Eaves and loft (images d, f, h & i)	<ul style="list-style-type: none"> - Thermal bridging (not packing loft insulation in tightly to edges) - Gaps in wall/loft insulation (difficulties in installation at construction joints) 	<ul style="list-style-type: none"> - Sheltered nature of feature, resulting in slow dispersal of heat accumulated here during daylight hours - Ventilation gap in loft space
Walls		
Patchy walls (images a-i)	<ul style="list-style-type: none"> - Poor workmanship of retrofitted cavity wall insulation - Areas of inadequate cavity wall insulation - Blocked-up vents with inadequate insulation and/or thermal bridging - Air gaps within wall construction 	<ul style="list-style-type: none"> - Different materials used within wall construction - Location of external lights (both on dwelling itself and streetlights reflecting light (and heat) onto external wall - Internal rooms heated to higher temperatures than others

Joints/connection details (images d, f & h)	<ul style="list-style-type: none"> - Thermal bridging due to lack of insulation at junctions between walls etc. - Poor workmanship of retrofit improvements - Junctions between original building and new extensions not adequately detailed and constructed 	<ul style="list-style-type: none"> - Sheltered nature of feature, resulting in slow dispersal of heat accumulated here during daylight hours
Windows and doors		
Heat loss around lintels (images b, c, f & g)	<ul style="list-style-type: none"> - Thermal bridging - Gaps in draught-proofing of windows/doors - Tricklevents in windows left open (required for ventilation) 	<ul style="list-style-type: none"> - Lintels made of different materials (eg. Concrete, timber) - Sheltered nature of feature, resulting in slow dispersal of heat accumulated here during daylight hours
Bay and extruded windows (images a & e)	<ul style="list-style-type: none"> - Poor construction particularly at joints allowing heat loss - Lack of insulation (difficult to install) 	<ul style="list-style-type: none"> - Different materials used within wall construction - Sheltered nature of feature, resulting in slow dispersal of heat accumulated here during daylight hours

Heat loss under window cills (images a-g)	<ul style="list-style-type: none"> - Lack of insulation (difficult to install) - Gaps in draught-proofing of windows - Poor workmanship in relation to sealing and draught-proofing window frames - Indicative of localised 'hot' spots (generally due to radiator located on external wall beneath window) 	<ul style="list-style-type: none"> - Sheltered nature of feature, resulting in slow dispersal of heat accumulated here during daylight hours
Door alcoves (image a)	<ul style="list-style-type: none"> - Lack of insulation in external walls in door alcoves - Poorly fitting doors and/or original doors and glazing panels retained with poor sealing/draughtproofing measures 	<ul style="list-style-type: none"> - Sheltered nature of feature, resulting in slow dispersal of heat accumulated here during daylight hours
Other		
Ground level heat loss (image f)	<ul style="list-style-type: none"> - Ventilation due to suspended flooring - Lack of insulation on ground floor of dwelling - Lack of damp-proofing course (DPC) 	<ul style="list-style-type: none"> - Dampness at ground level - Vegetation at ground level - Different materials

Given the complexities in interpreting thermal images, it is often difficult to ascertain the exact causes of anomalies in the images. Further investigation of ‘hot’ spots below windows in particular would be recommended, as it could be symptomatic of poor installation of cavity wall insulation or the glazing systems themselves.
