SURVEY DATE & CONDITIONS: February-March 2013; 4 hours after sunset (cold, dry and mainly cloudy).

NO. OF HOUSEHOLDS IN SURVEY: 54

1. Introduction

This briefing note outlines the findings of thermal imaging surveys of 54 dwellings in six communities across England and Wales. The majority were built in the post-war era; between 1945 and 1980 (34 in total). The predominant dwelling types are detached and semi-detached. The majority have a mixed material finish to the front façade; mainly either exposed brick or rendered brick finish.

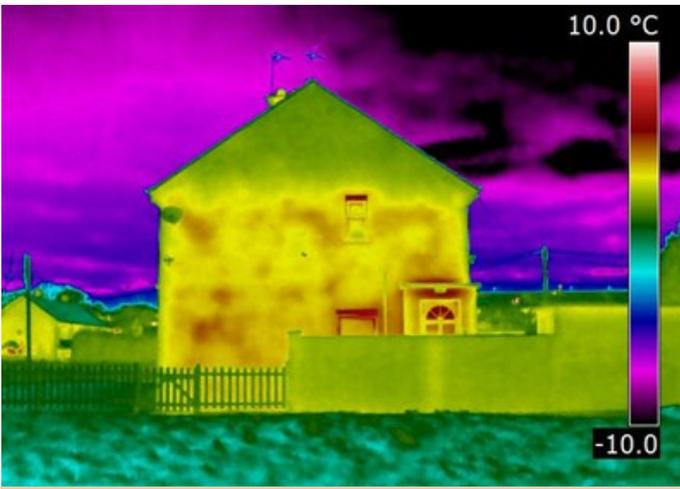
The thermographic images highlight inconsistencies in the appearance of the walls in 34 of the 42 dwellings.

This is potentially indicative of issues relating to missing or defective retrofitted insulation. Previous research suggests that there a number of reasons for this, even if the insulation has been installed to industry standards including:

Patchy wall façade indicative of poor installation of cavity wall insulation; clear line along roof line suggests good performance of loft insulation.

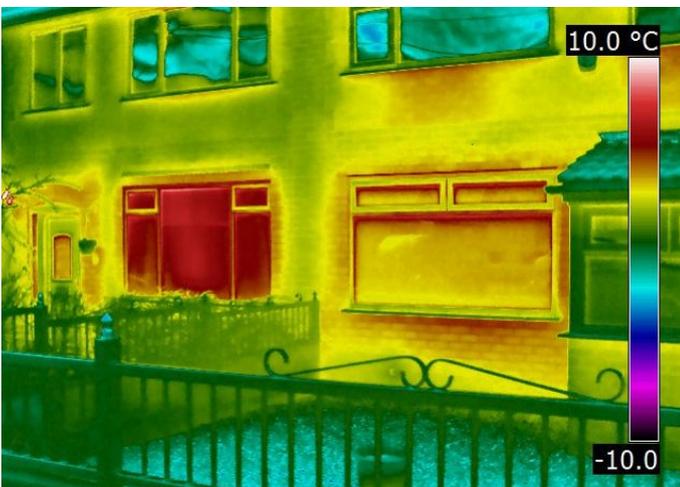
Areas of localised heat loss beneath windows apparent in dwelling to right (dwelling to left has radiator reflector panels installed).

42 out of the 54 dwellings have areas of higher temperatures below the cills. Whilst the usual problems with interpreting protruding features apply, the inconsistent pattern of most suggests that this could be due to a number of issues:

- Poor installation and sealing of the window unit,
- Lack of insulation being packed tight up to the window opening (gaps in insulation),
- Localised areas of heat loss due to the location of radiators on the external wall.

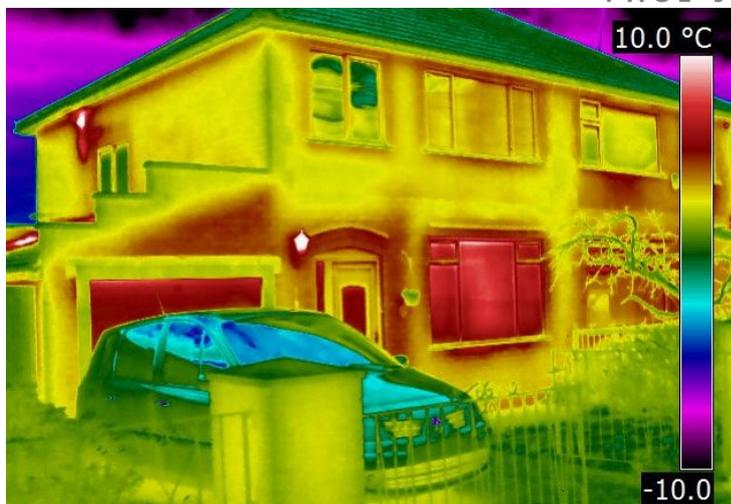
Unheated garages also appeared to show heat loss, suggesting inadequate insulative barrier between the main heated areas and such unheated adjoining spaces.

Area of possible heat loss shown in unheated garage; highlights need for adequate insulation and sealing between adjoining heated and unheated spaces.

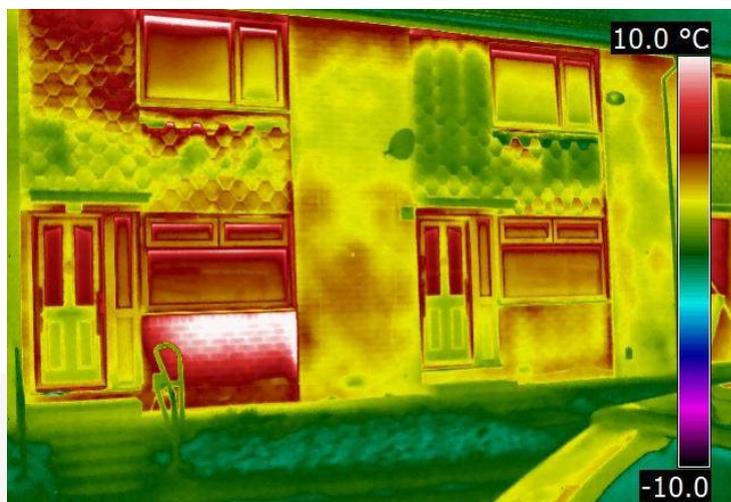
The thermal images indicate inconsistencies across tile cladding and infill panels. Whilst the different materials (and therefore emissivity) may have implications on this, the unevenness of the façade suggests that areas are suffering from insulation issues; either missing or incomplete installation, the delamination of the wall cladding from the main wall structure, or the degradation of the infill panel material.

Heat loss below window (brick finish but likely to be uninsulated; fluctuations across facade(possible deflection and peeling away of cladding).
