1. Introduction

Hook Norton Low Carbon (HNLC) is one of the six case study community initiatives. The project was delivered through a co-operative and community benefit society, set up by volunteers from the local community group, Low Carbon Hook Norton. The LCCC funding helped with a number of initiatives in the area including interest-free loans for householders to undertake substantial retrofit projects.

This report summarises the findings of a thermographic survey conducted on 13th March 2013 of these 17 homes.

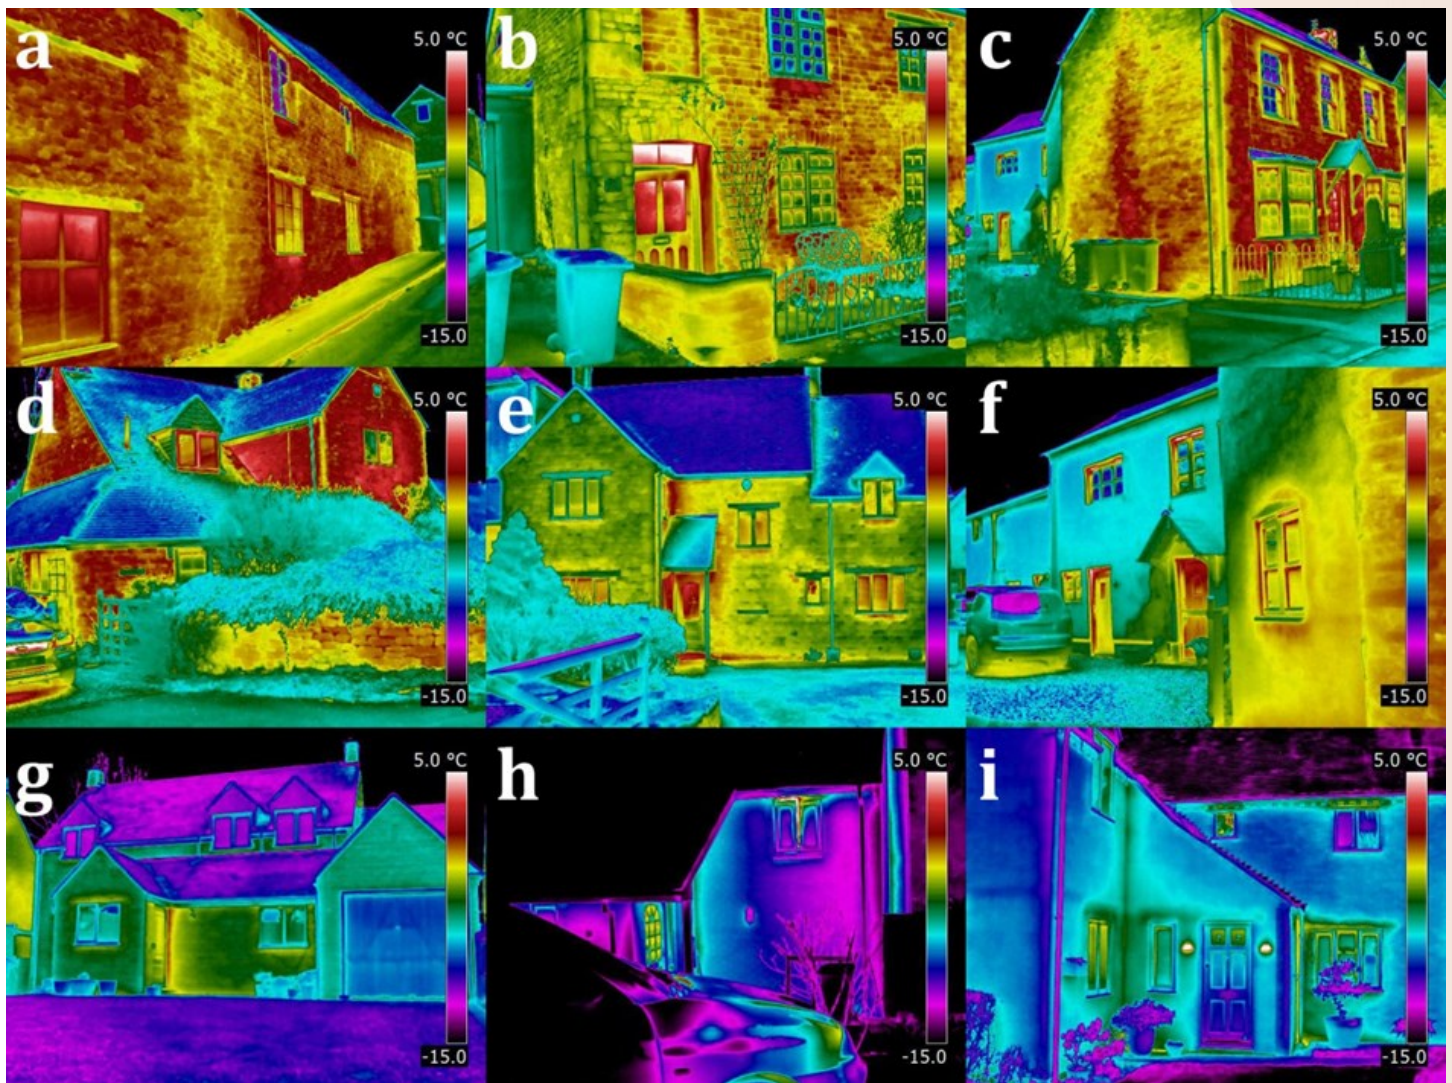
Table 4 is a summary of the most common issues identified, as also demonstrated in the images in Figure 2.

Within the dwellings built post-1965, there appeared to be quite a disparity in surface temperatures. Whilst external constraints should be taken into consideration, it does suggest differences in quality of construction between dwellings. Figures 2d and 2g are both 1965-80 detached dwellings, with stone finish. However, the dwelling shown in 2g has undergone substantial renovation, and improved fabric interventions. Similarly, Figures 2e, 2h and 2i are all detached properties built between 1981-90, yet demonstrate potential different levels of heat loss. It must be noted however, that the dwellings shown in Figures 2h and 2i are brick finish, whilst 2e is stone. Overall however, the appearance of the cavity wall dwellings appears generally 'smooth' and as such suggests a good quality of construction.

Within a number of dwellings, there appear to be 'hot spots' below windows, which suggests a need for draughtproofing and/or poor quality window installations (Figures 2a and 2e). Interestingly, in Figure 2a, there are no radiators below the windows, indicating that this is not simply an issue of increased localised heating.

A number of the solid wall dwellings show 'patchy' surfaces to the external wall but these generally correspond with the stone, and it is believed that due to the majority of these dwellings being built with random stone, this may simply be indicative of the different types of stone used in the construction. Figure 2f demonstrates the impact of external

solid wall insulation on reducing heat loss, whilst also highlighting possible areas of heat loss around window and door frames. Figures 2b and 2c further indicate two main areas of heat loss (other than below windows) in solid wall dwellings in this survey; poorly sealed external doors and fanlights, and chimneys.

Problem area	Potential reasons	Potential constraints
Walls		
Patchy walls (images a, b & e)	<ul style="list-style-type: none"> - Poor workmanship of retrofitted cavity wall insulation - Areas of inadequate cavity wall insulation - Blocked-up vents with inadequate insulation and/or thermal bridging - Air gaps within wall construction 	<ul style="list-style-type: none"> - Different materials used within wall construction - Location of external lights (both on dwelling itself and streetlights reflecting light (and heat) onto external wall - Internal rooms heated to higher temperatures than others
Joints/ connection details (images d, e & g)	<ul style="list-style-type: none"> - Thermal bridging due to lack of insulation at junctions between walls etc. - Poor workmanship of retrofit improvements - Junctions between original building and new extensions not adequately detailed and constructed 	<ul style="list-style-type: none"> - Sheltered nature of feature, resulting in slow dispersal of heat accumulated here during daylight hours

Chimney breasts (image c)	<ul style="list-style-type: none"> - High temperatures due to use of fire; lack of insulative lining - Direct access for air flow in and out of building 	
Windows and doors		
Heat loss around windows/ doors (images b, e & f)	<ul style="list-style-type: none"> - Thermal bridging - Gaps in draught-proofing of windows/doors - Poor construction particularly at joints allowing heat loss - Lack of insulation (difficult to install) 	<ul style="list-style-type: none"> - Different materials used within wall construction - Sheltered nature of feature, resulting in slow dispersal of heat accumulated here during daylight hours
Heat loss under window cills (images a, c, e & g)	<ul style="list-style-type: none"> - Lack of insulation (difficult to install) - Gaps in draught-proofing of windows - Poor workmanship in relation to sealing and draught-proofing window frames - Indicative of localised 'hot' spots (generally due to radiator located on external wall beneath window) 	<ul style="list-style-type: none"> - Sheltered nature of feature, resulting in slow dispersal of heat accumulated here during daylight hours - Cills made of different materials (eg. Concrete, timber)

Other		
Ground level heat loss (image a, c & f)	<ul style="list-style-type: none"> - Ventilation due to suspended flooring - Lack of insulation on ground floor of dwelling - Lack of damp-proofing course (DPC) 	<ul style="list-style-type: none"> - Dampness at ground level - Vegetation at ground level - Different materials

Figure 4. Images a-c are of dwellings with solid wall construction; Images d, e are of cavity wall dwellings with insulation as existing; Image f is of a solid wall dwelling with retrofitted external wall insulation; Image g is of a cavity wall dwelling with recent fabric improvements; Images h and I are of cavity wall dwellings with insulation as existing.

Given the complexities in interpreting thermal images, it is often difficult to ascertain the exact causes of anomalies in the images. Further investigation of 'hot' spots below windows in particular would be recommended, as it could be indicative of poor installation of the glazing systems.
